CARR - 766

522 HOOK ROAD

## FIELD SHEET--HISTORIC RESOURCES SURVEY

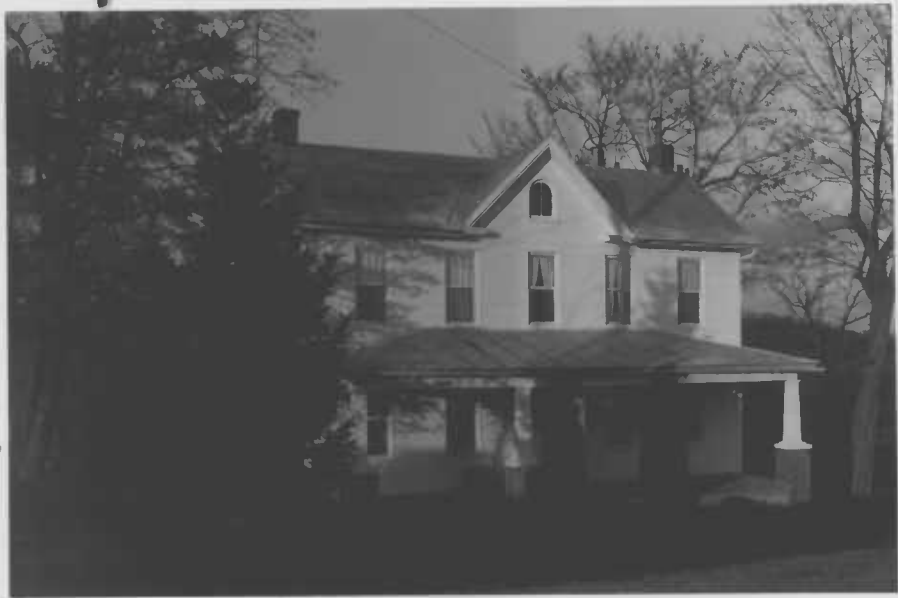
CARR-766

522 Hook Road is a late nineteenth century farmhouse that demonstrates the rural Victorian farmhouse style found frequently in Carroll County. This style basically incorporates the regional characteristics with the addition of a gabled dormer. This example has a full-length, one-story front porch with brick piers that date from the twentieth century. There is a late nineteenth century bank barn on the property.

South facade
